Revision Guide for AMD Athlon™ 64 and AMD Opteron™ Processors

| Publication # 25759 | Revision: 3.57 |
| Issue Date: August 2005 | |

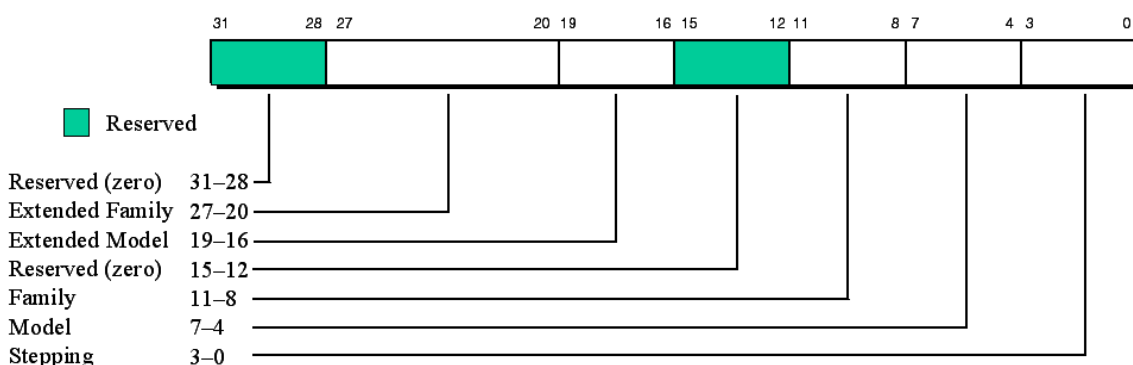
Figure 1 shows the format of the value returned in EAX by CPUID Function 1.

Figure 1. Format of CPUID Value Returned by Function 1
